Manhole Inspection Summary

Manhole # S17S__004MH

Location Address: **2717 WILMARCO AV**

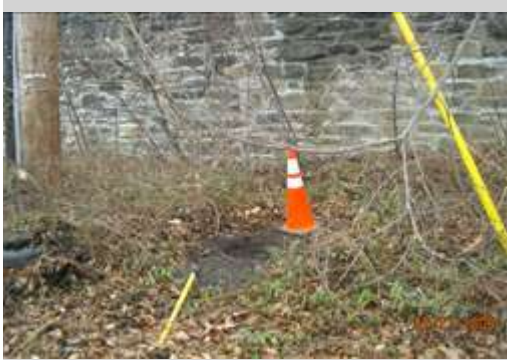
MISC.

REMOVED MODERATE BRUSH,
DEBRIS, AND LEAF COVER/SOIL, TO
EXPOSE MANHOLE FOR INSPECTION

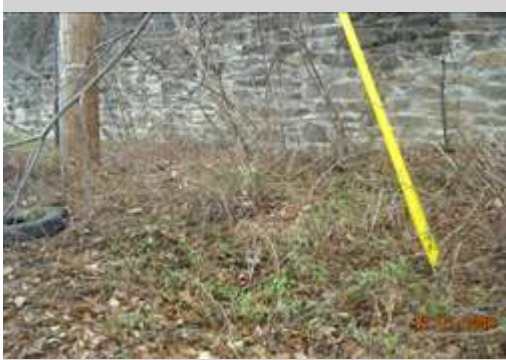
MISC.

AREA BEFORE EXPOSING MANHOLE

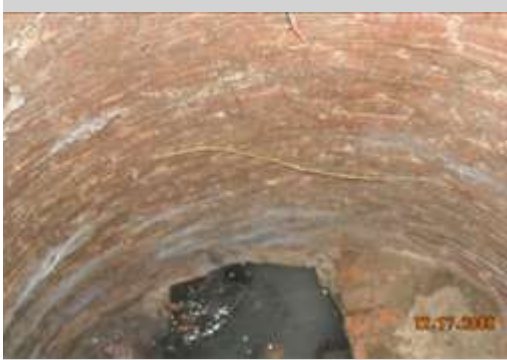
Defect 4

Condition: ☐ Sound ☐ Cracked ☒ **Root Intrusion** ☒ **Loose Brick** ☐ Deteriorated

ROOT INTRUSION @ BARREL WALL

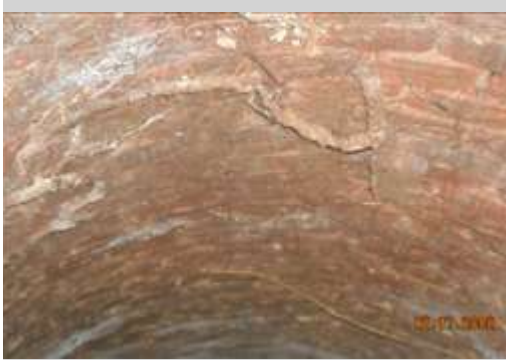
Defect 3

Condition: ☐ Sound ☐ Cracked ☒ **Root Intrusion** ☐ Loose Brick ☐ Deteriorated

ROOT INTRUSION @ CORBEL WALL

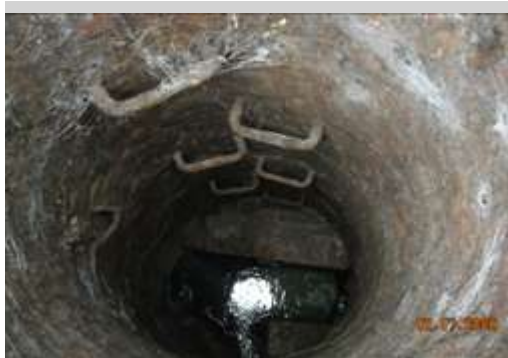
Defect 2

Count: **7** Missing: **0** ☒ **Corroded**

CORRODED STEPS

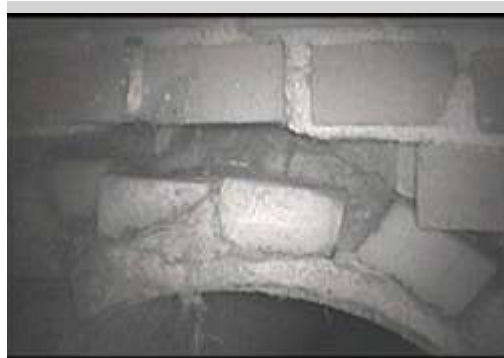
Defect 1

LOOSE BARREL BRICKS

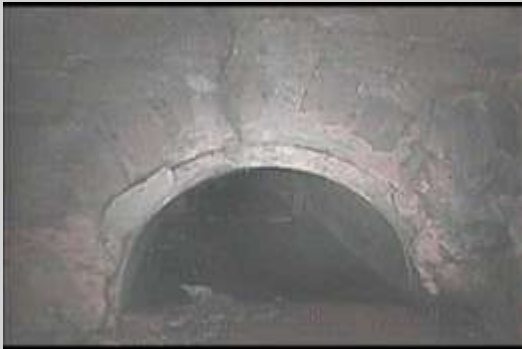
12 O'Clock Outflow

Pipe Height: **15.6** (in.) Rod and Bar (Angled)
Pipe Material: **Clay** ☐ Pipe Lined
Invert Depth: **13.20** (ft.) Flow Characteristics: **Slow**
Deposits: ☐ None ☐ Mud ☒ Sludge ☒ Debris ☐ Grease
Silt Depth: **4** (in.) Deposits Extent: **Medium**
Infiltration: **None** Pipe Seal Cond: **Cracked**

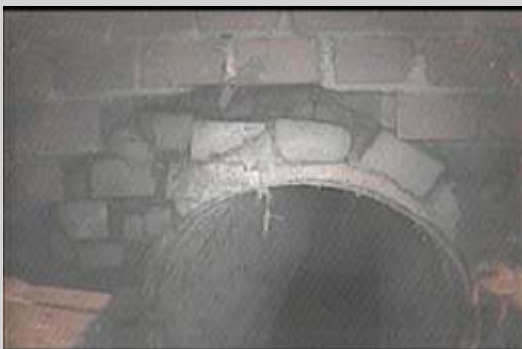
6 O'Clock Inflow

Pipe Height: **15.6** (in.) Rod and Bar (Angled)
Pipe Material: **Clay** ☐ Pipe Lined
Invert Depth: **12.05** (ft.) Flow Characteristics: **Slow**
Deposits: ☒ None ☐ Mud ☐ Sludge ☐ Debris ☐ Grease
Silt Depth: **0** (in.) Deposits Extent:
Infiltration: **None** Pipe Seal Cond: **Broken**

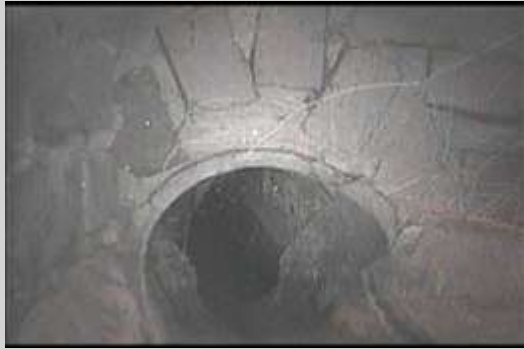
9 O'Clock Inflow

Deposits: ☐ None ☐ Mud ☐ Sludge ☐ Debris ☒ **Grease**

Silt Depth: **3** (in.) Deposits Extent: **Medium**

Infiltration: **None** Pipe Seal Cond: **Roots**
